## Service Info

# Grabbing clutch

Possibly caused by incorrect adjustment of the clutch booster

**Modelos:** Actros MP 2 (2003 -2008)  
Actros MP 3 (2008 -)

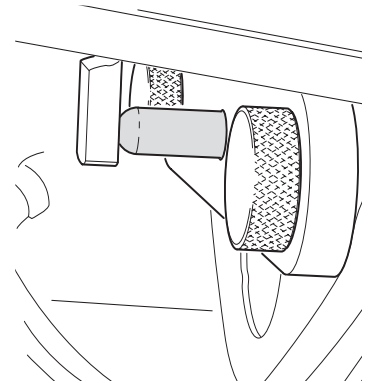
Image 2: Adjustment device from the vehicle manufacturer (part no.: 930 589 00 23 00)

In the event of a complaint, the setting of the ram of the clutch booster must be checked first. This can be done using an adjustment device from the vehicle manufacturer.

- Remove the ram from the release lever, unscrew the lock nut and reset the ram
- Attach the adjustment device (image 2, left)
- Twist the shaft of the ram until it fits closely with the adjustment device without any play (image 2, right)
- Remove the adjustment device
- Remove the ram and retighten the lock nut
- Insert the ram
